SERVICE BULLETIN AMATEUR RADIO

SUBJECT TS-950S/SD RECEIVER NOISE	DATE 05/29/90
-----------------------------------	---------------

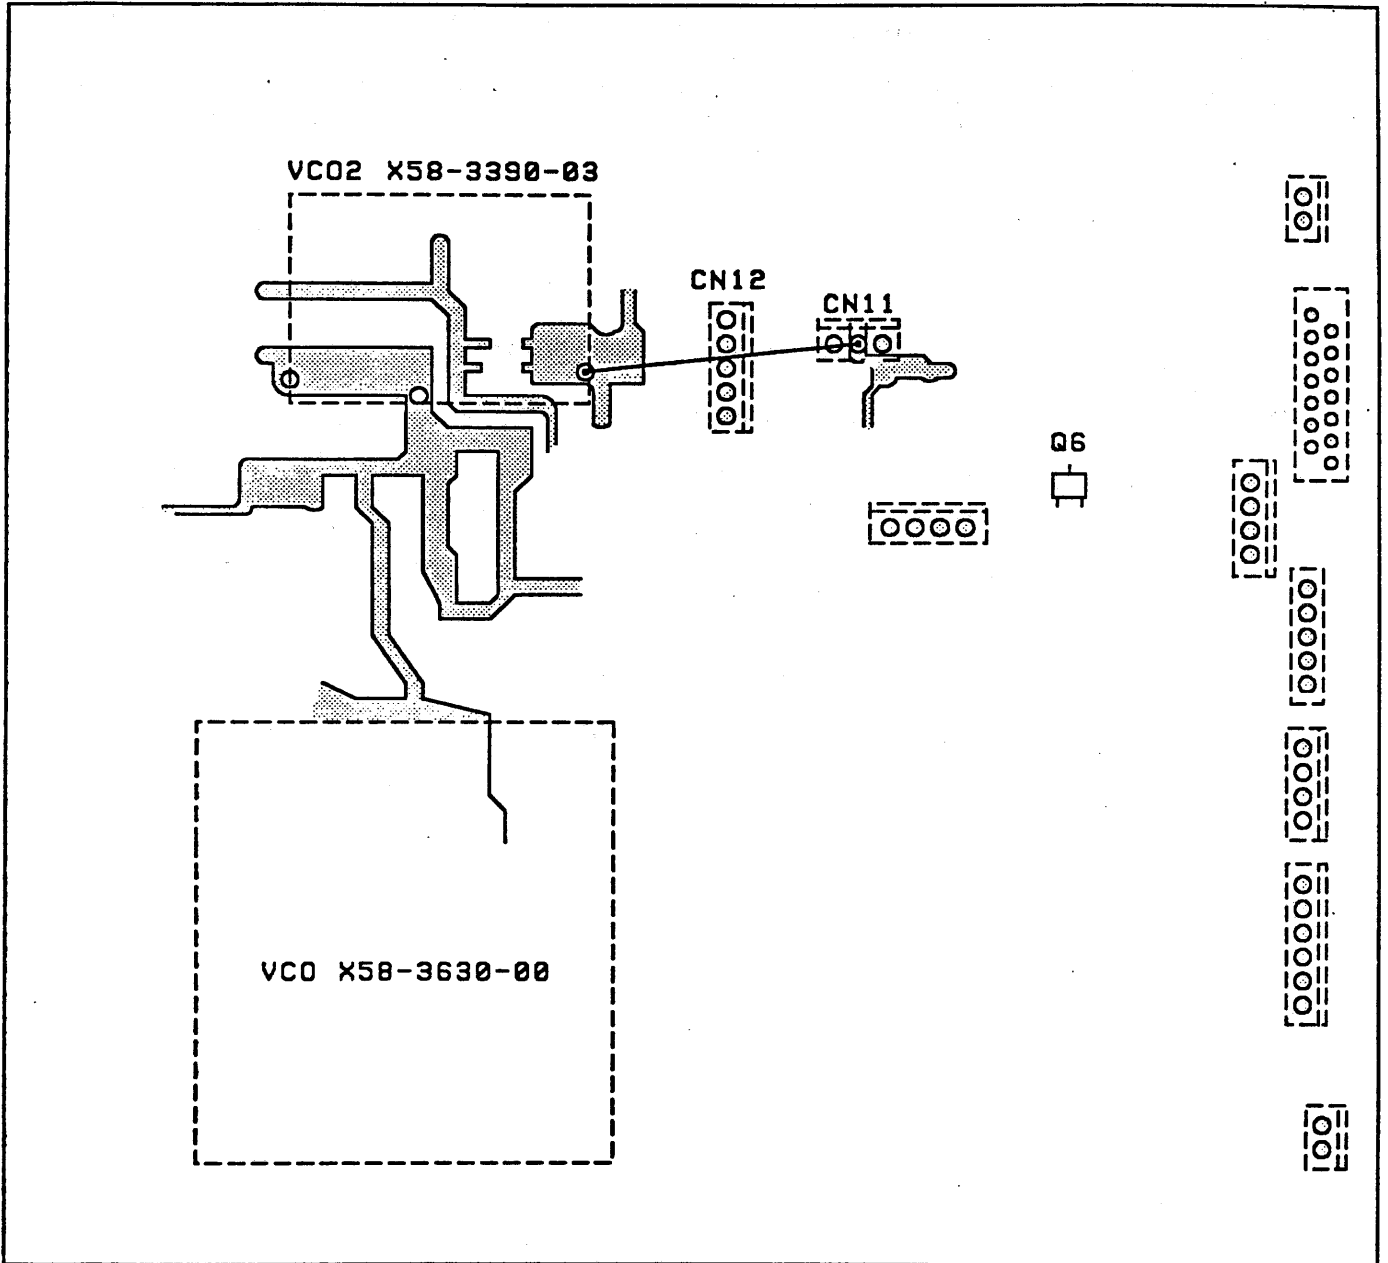
AF UNIT X49-3020-00

About 1mV of noise is present at the speaker or headphone jack in the receive mode with the AF GAIN control set to minimum. If the transceiver is in the CW mode, a faint tone might also be heard through the headphones (sidetone leakage). The following modification will reduce the level of the noise and the tone.

1. Disconnect the power cord and antenna.
2. Remove the top and bottom covers (18 screws).
3. Locate the AF unit on the bottom of the transceiver. This is the front left board of the four boards on the bottom of the transceiver.
4. Remove the screws from the AF unit and disconnect the plugs as necessary to turn the board over to expose the foil side of the board.
5. Replace Q6 with a 2SD1757K(S).
6. Solder a 22 AWG jumper wire as shown in figure 1.
