ASB-1003

## Service Bulletin

**Subject:** TS-950SDX w/K1EA Ver.8 Program  
1992

**Date:** November 18,  
1992

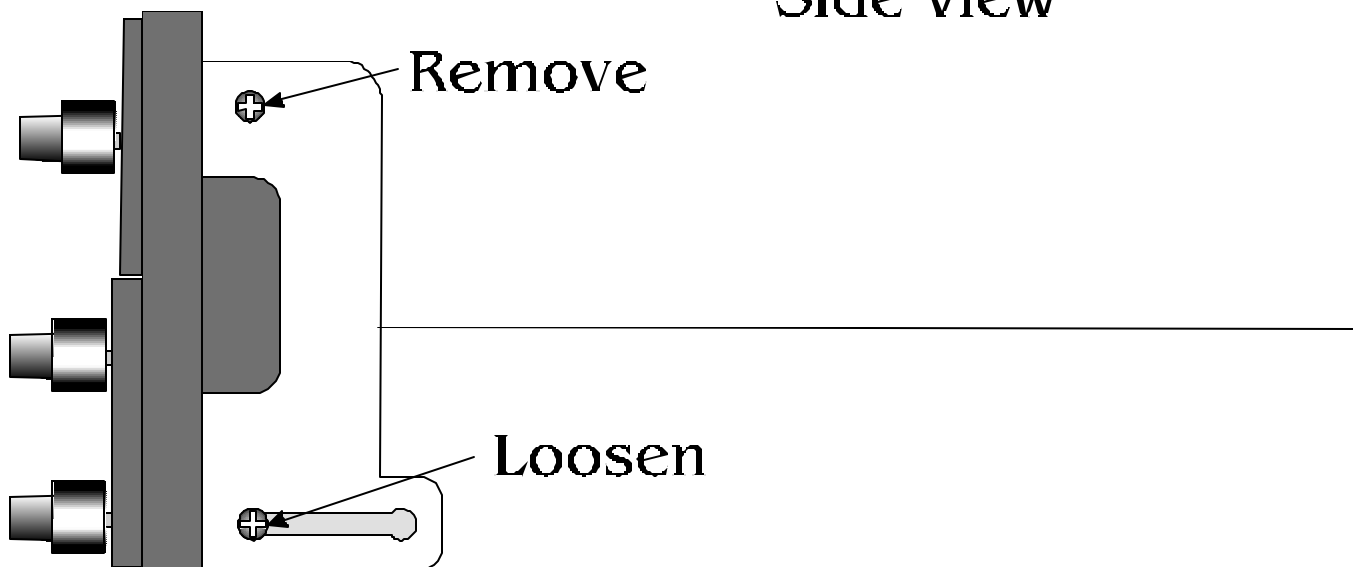
## TS-950SDX Side view

We have received several reports of the transmitter unkeying when using the K1EA Contesting program. This symptom only occurs when the TS-950SDX is used with version 8 of the K1EA program. Apparently some of the more advanced control features of this new version of the program cause the radio to think the program has unkeyed. A new EPROM is available that corrects this transmitter drop out.

1. Remove the top and bottom covers of the TS-950SDX.
2. Carefully unplug the two DSP unit cables from the rear of the transceiver.
3. The front panel of the radio is designed to allow it to be tilted forward for ease of service. To tilt the front panel forward remove the screw at the top of the brackets that secure the front panel to the chassis. (Please refer to the accompanying diagram.) There is one screw on each side of the front panel.

4. Next loosen the remaining screw at the bottom of each bracket.
5. Gently pull the bottom of the front panel forward until it reaches the end of the slot in the bracket and gently pull the top of the front panel down.
