ASB-1017

## Service Bulletin

**Subject:** TS-950 Noise with Sub-Band Noise Blanker ON  
1993

**Date:** May 13,

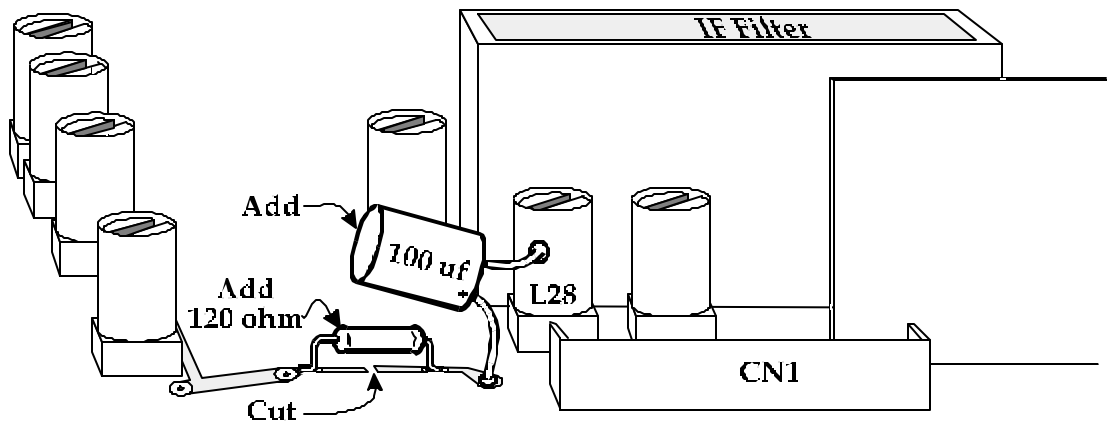
**X48-3060-00  
Component Side View**

Noise is generated when NB1 is switched on for the sub-receiver.

Switching noise from the noise-blanker gate enters the AF amplifier via the +15 V line causing the noise.

1. Cut the pattern of the 15 V line on the IF Unit (X48-3060-00) component side, near Q34's emitter and add the 120 ohm resistor as shown in the accompanying diagram.
2. Add the electrolytic capacitor as shown in the diagram. Quickly solder the negative lead to the metal shield of L28.
