ASB-1018

## Service Bulletin

**Subject:** TS-950 14.200 MHz Transmit Spur

**Date:** May 14, 1993

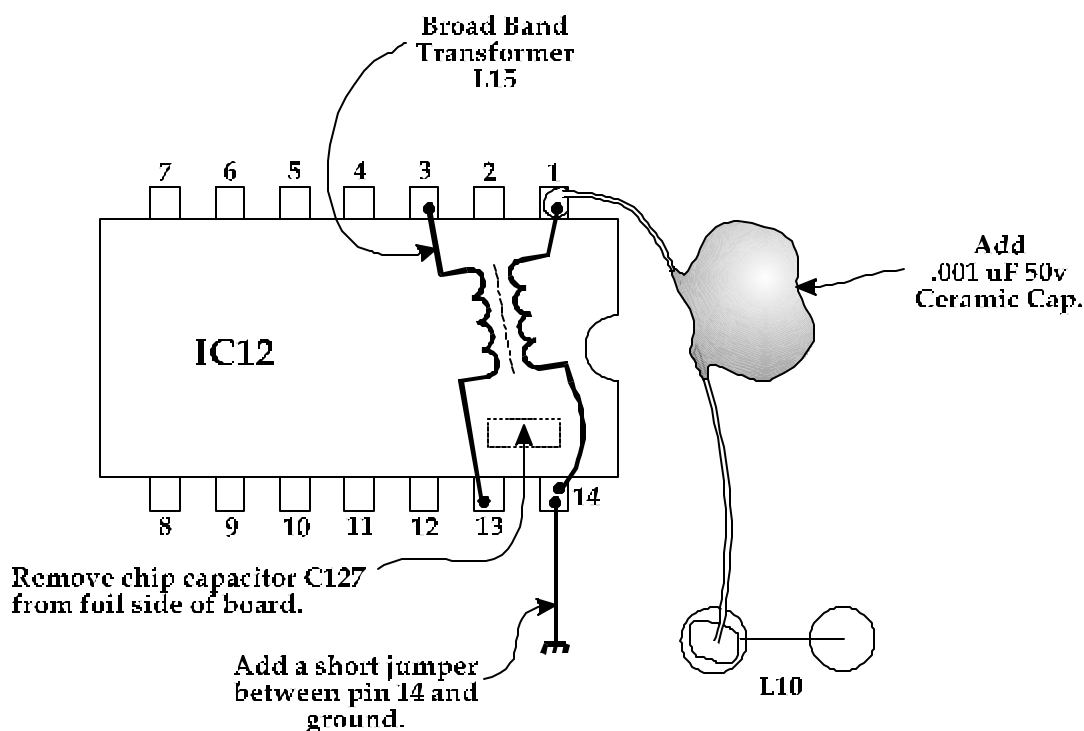
### AF Unit (X49-3020-00) Component Side View

A close-in transmit spur might be present on early model TS-950(S) (Serial Number 1010XXX and below) transceivers when operating at a dial frequency of approximately 14.200.0 MHz. This spur is seen approximately -40 to -50 db down from the fundamental.

The output from the mixer (IC12) which generates the final PLL loop comparison frequency for the AF unit contains harmonic radiation at approximately 36 to 68 MHz.

1. Solder the primary of the transformer to pins 3 and 13 of IC12. You will have to bend the terminals slightly.
2. Solder the secondary of the transformer to pin 1 and 14 of IC12.
3. Remove chip capacitor C127 from the foil side of the board.
4. Connect pin 14 of IC12 to the ground pattern.
5. Add the new C127 from pin 1 of IC12 to L10 as shown in the accompanying illustration.
