KENWOOD

ASB-1020

Service Bulletin

Subject: TS-950 Infinite SWR at Beginning of Transmission **Date:** May 14, 1993

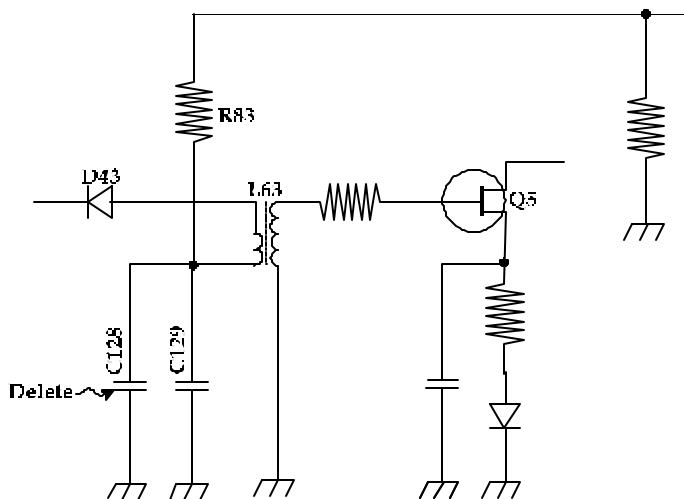
RF Unit (X44-3100-00)

During "Full Break-in" operation the SWR meter shows infinite SWR at the beginning of transmit. This results in a reduction of the transmitter power, followed by a gradual increase to normal full power. This symptom does not occur with the antenna tuner set to "THRU".

Normally the RXB line should be 0 vdc at the beginning of transmit operations. We have found that this does not always occur. The length of time required for transmit power to return to normal is directly related to the time constant of capacitor C128 on the RXB line.

Removing this capacitor corrects the above symptom, but might affect the receiver sensitivity at a dial frequency of 100 kHz. This action is only recommended if the symptom is actually present. Do not modify the unit if the symptom is absent!
