KENWOOD

ASB-1024

Service Bulletin

Subject: TS-950S/SD Transmit Spur
1993

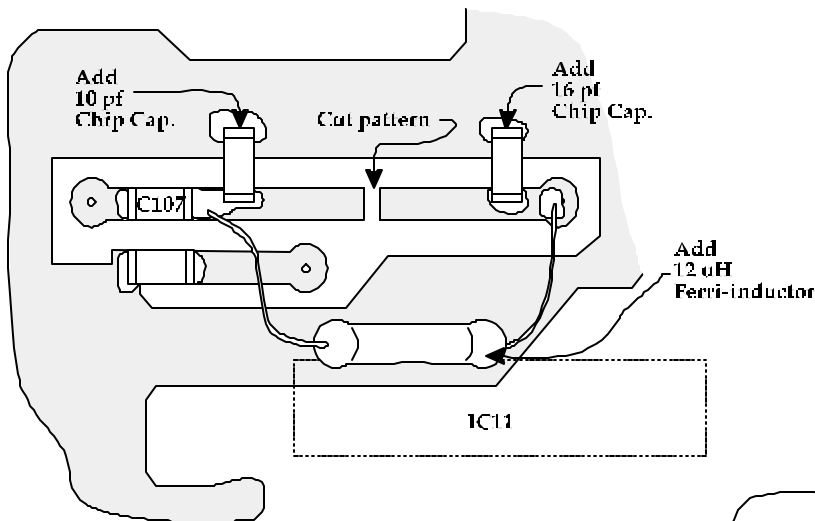
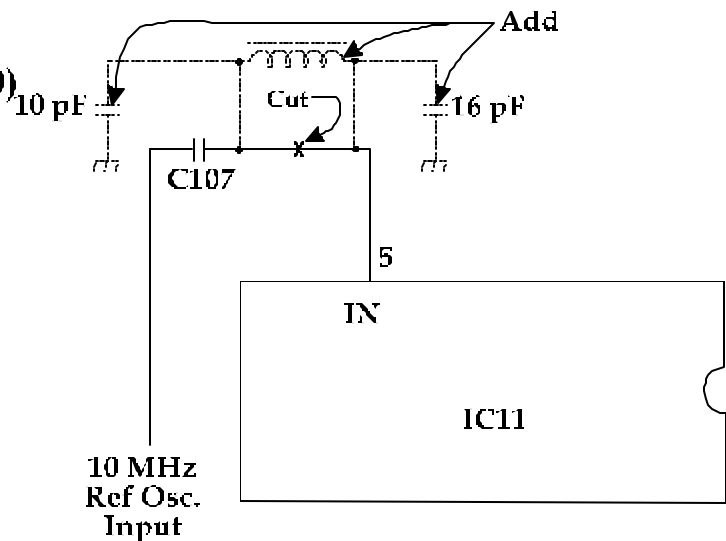
**AF Unit (X49-3020-00)
Foil Side View**

A transmitter spur might be present at a dial frequency of XX.XX1 MHz. This spur is quite small but might become noticeable when the transceiver is used with a linear amplifier.

The transmitted signal enters pin 5 of IC11 which is in the last PLL loop in the AF unit due to RF feedback. This pin is the input for the 10 MHz Ref Osc signal from the CAR unit. IC11 is the source of the spurious signal since both the band and 10 MHz frequencies are divided by the 500 kHz comparison frequency supplied by IC11.

To reduce this RF feedback increase the Ref Osc level from .2V to .7V rms by adding the accompanying circuit to the input of IC11.
